# HISTORICAL AND ARCHITECTURAL OVERVIEW

HOUSE OF GEORGE W. DAVIES

BROADWAY

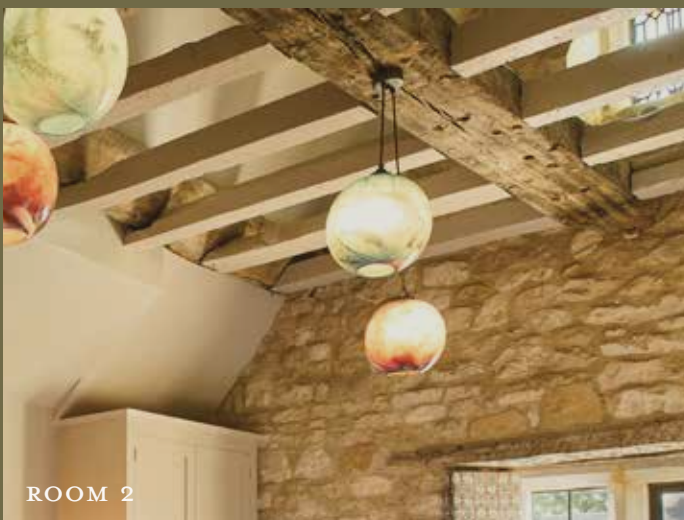
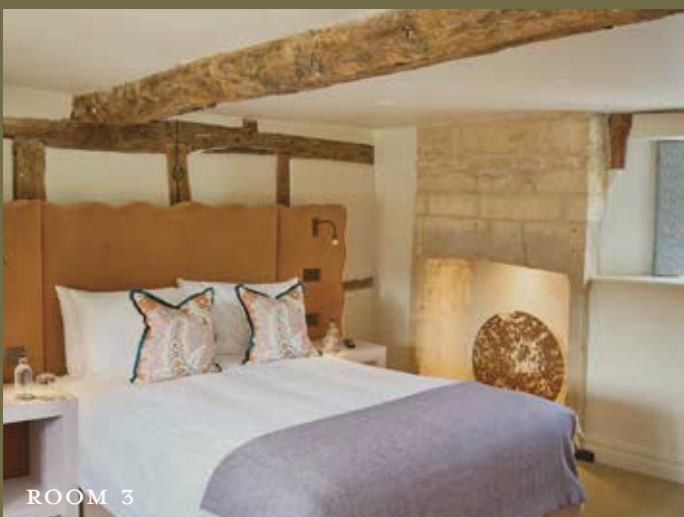
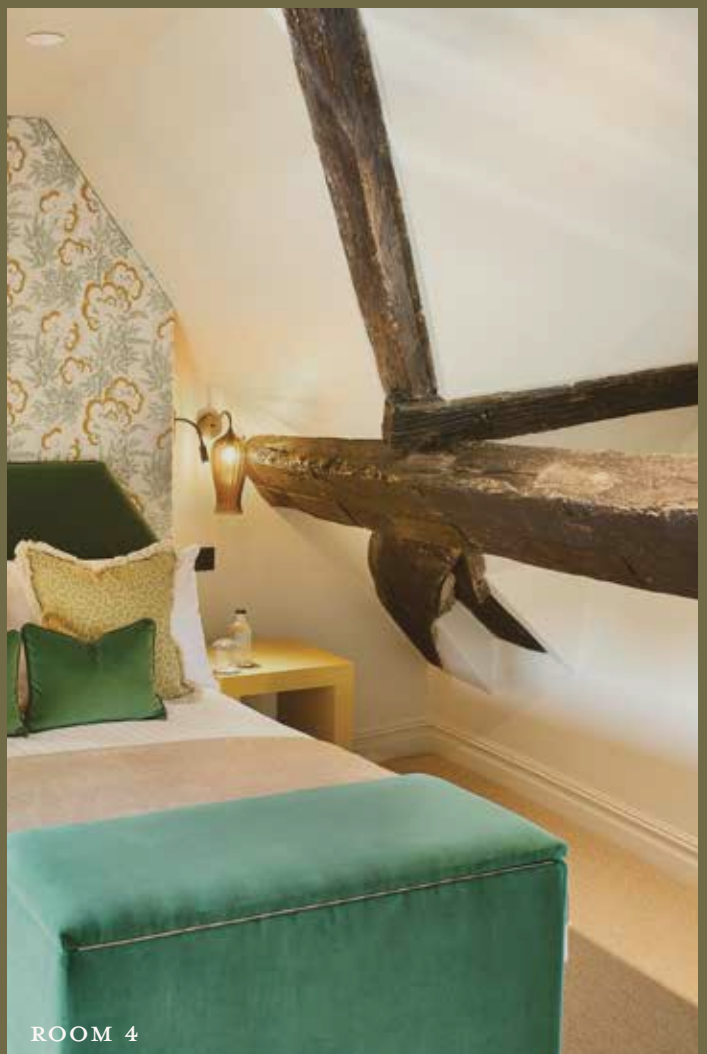
**ROOM 2:** Vaulted ceiling with an exposed 15th/16th century cross frame, comprising a tie beam, principal rafters, and a collar.

**ROOM 3:** Early to mid-17th century timbers form a focal wall, accompanied by a stone fireplace from the same period.

**ROOM 4:** Exposed timbers from the 15th century, including a tie beam, principal rafters, and a collar, with the carpentered face on the eastern side.

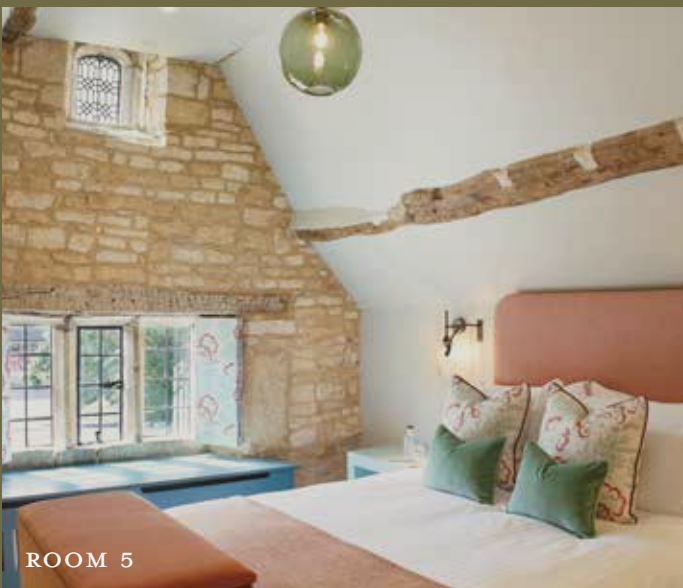
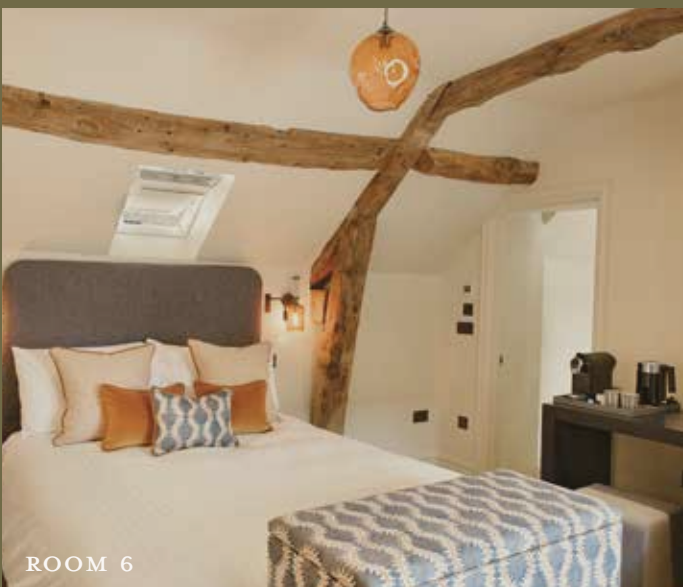
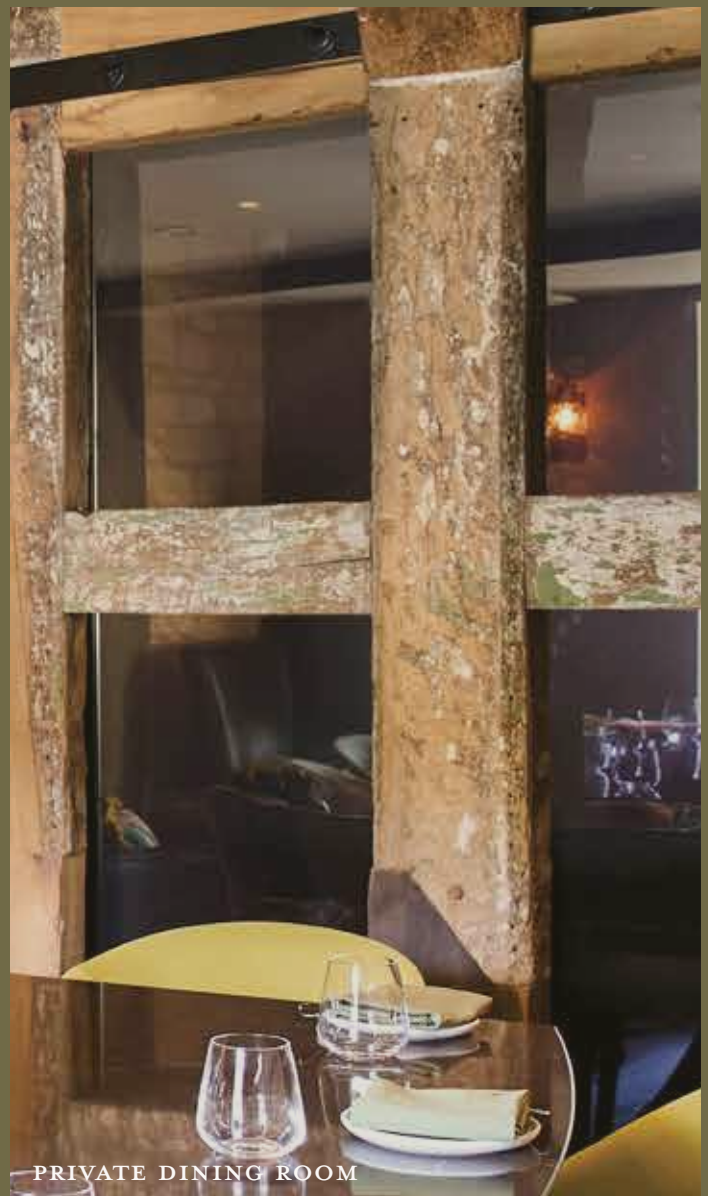
**ROOM 5:** The original cruck frame is visible, together with exposed timbers from the 18th century, offering a tangible connection to the building's origins.

**ROOM 6:** Showcases exposed timber frames dating from the 15th century.

**PRIVATE DINING ROOM:** Contains a cross frame from the mid-17th century within the timber frame, separating the dining room from the snug.
